**Subject:** Removal Assessment Report  
**Tanglefoot Lane Site, Bettendorf, Iowa**  
**EPA SEMS Identification No. IAN000703123**  
**U.S. EPA Region 7, START 5, Contract No. [REDACTED]**  
**Task Order No. 21F0035**  
**Task Monitor: Andrew Gieseke, EPA On-Scene Coordinator**

**REMOVAL ASSESSMENT REPORT  
TANGLEFOOT LANE SITE  
BETTENDORF, IOWA**

**EPA SEMS ID – IAN000703123**

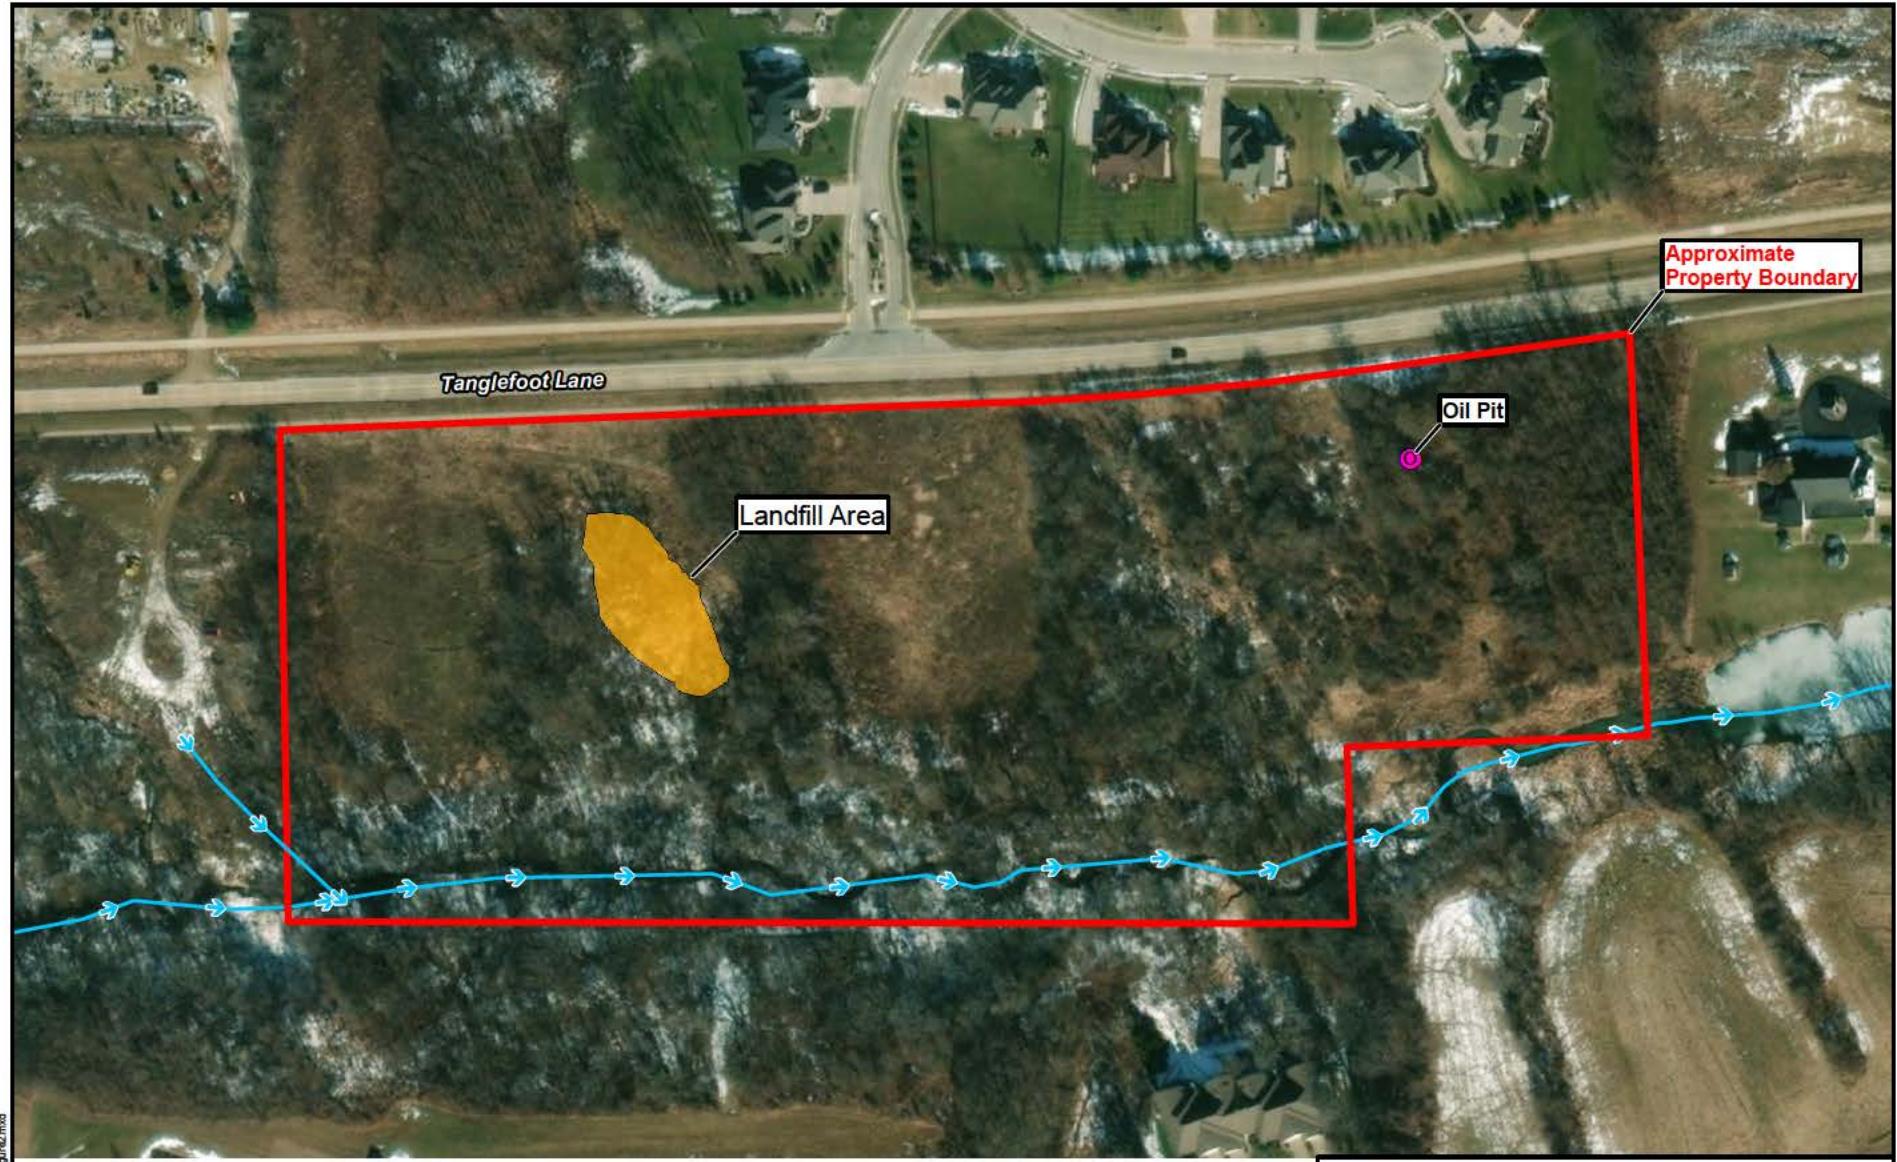
- Oil pit location
- ← Creek
- Approximate property boundary
- ◆ Estimated landfill area

Observed geology in the vicinity of the former oil pit (see Appendix A, Figure 2) included surface debris in a limited area, silty clay loam and loess, and well-rounded oxidized sand. Thin, dry, discontinuous sand lenses were observed above 20 feet bgs.

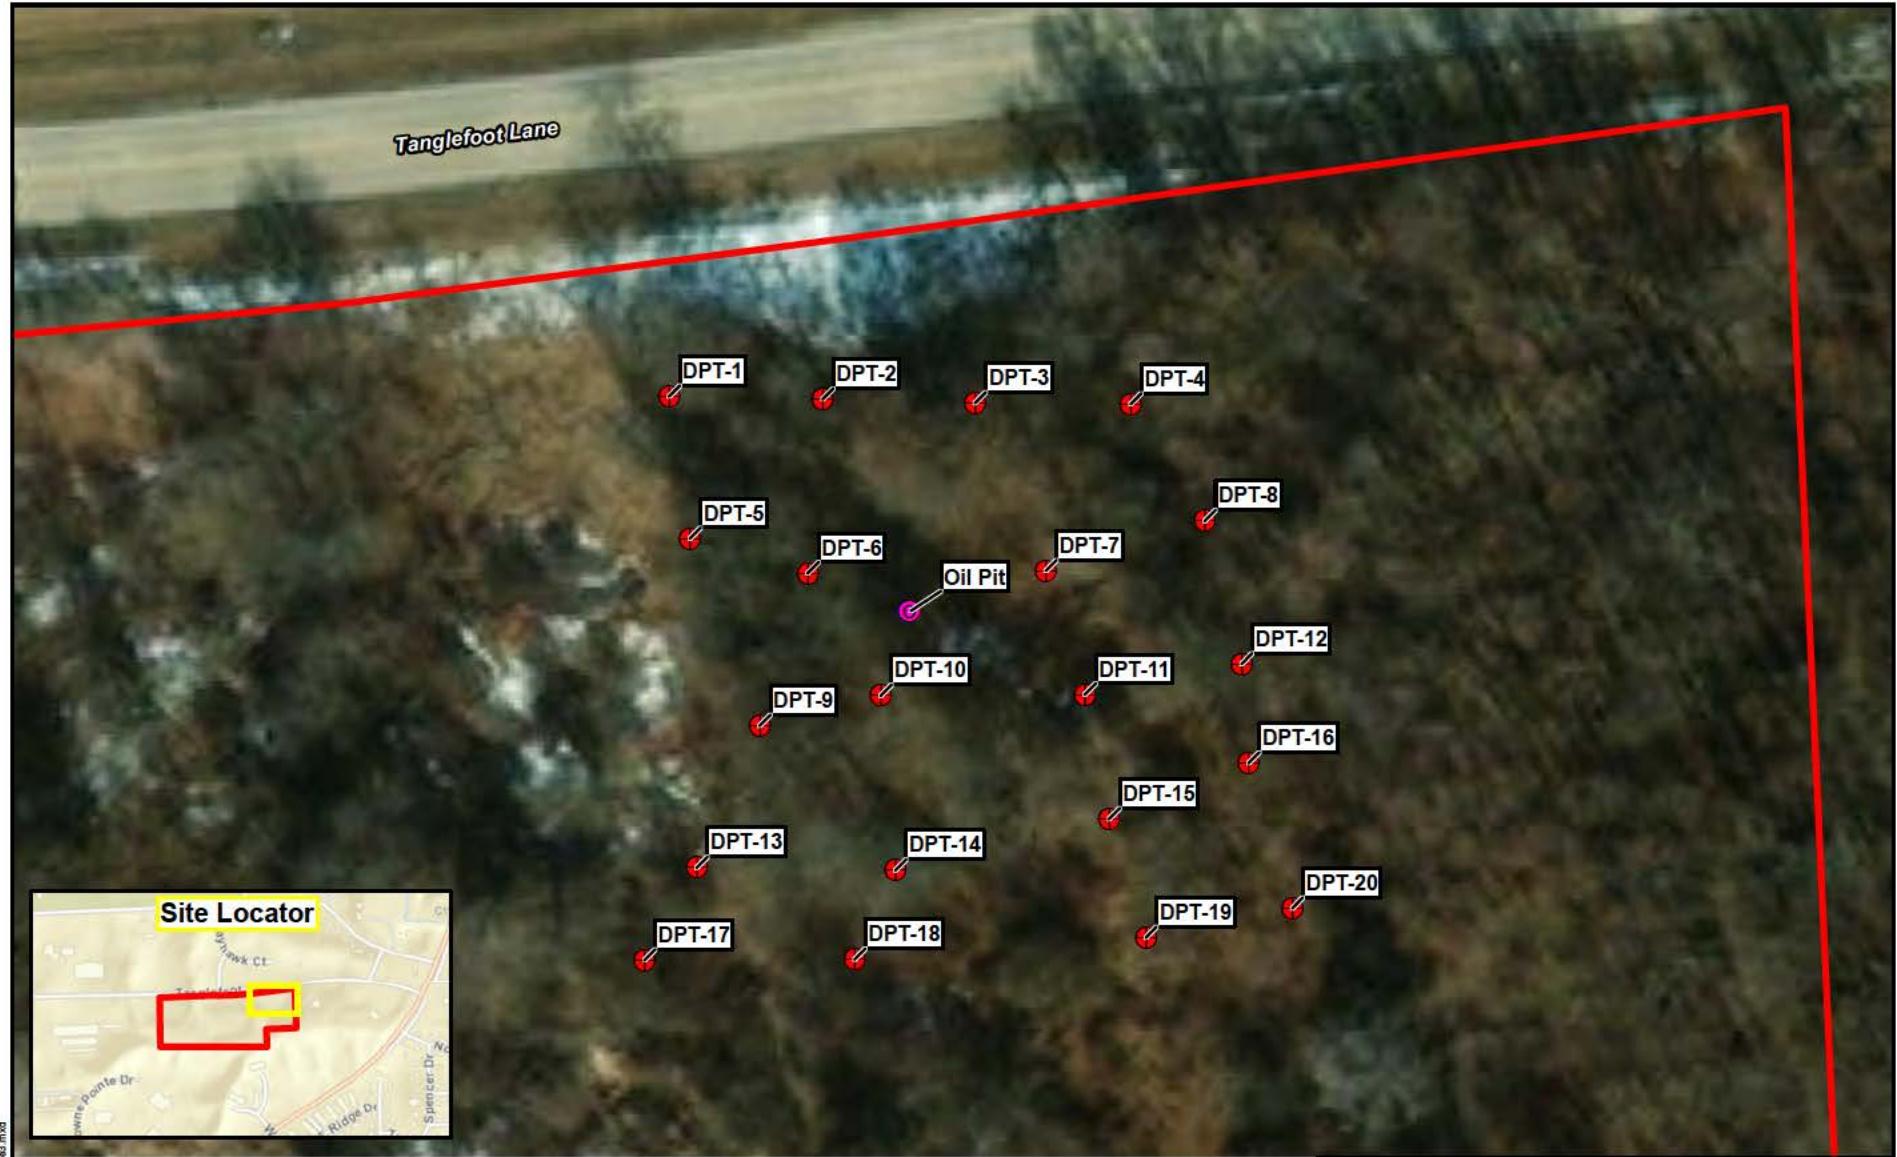
- Oil pit location
- DPT soil sample location
- Approximate property boundary
- DPT Direct push technology

Using a track mounted DPT rig, START advanced borings at 20 locations around the “oil pit” area of the site (see Figure 3 in Appendix A). At each DPT soil sampling location, a soil sampler containing a disposable polyvinyl chloride (PVC) liner was advanced via the DPT rig to 10 feet bgs. START field-screened soil cores for VOCs using a handheld photoionization detector (PID). START noted no elevated VOC readings or other evidence (visible or olfactory) of contamination. Two soil samples were collected at each soil boring—one within approximately 4 to 5 feet bgs and a second within 9 to 10 feet bgs.

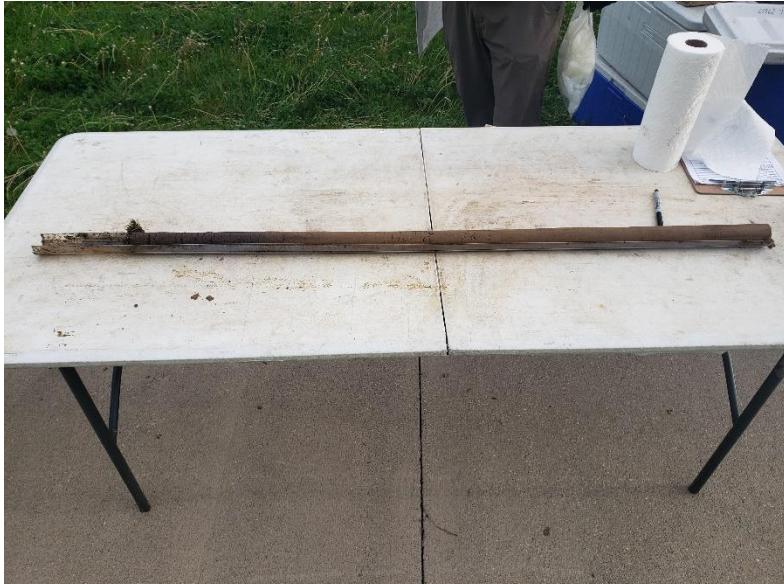
TETRA TECH PROJECT NO. 103X903021F0035  Direction: N/A	DESCRIPTION	This photograph shows direct-push technology (DPT)-4 soil core from 0-5 feet below ground surface (bgs). Sample collected within 3-5 feet bgs identified as 8811-1.	1
	CLIENT	U.S. Environmental Protection Agency Region 7	Date
	PHOTOGRAPHER	Tim Barbeau	5/4/2021

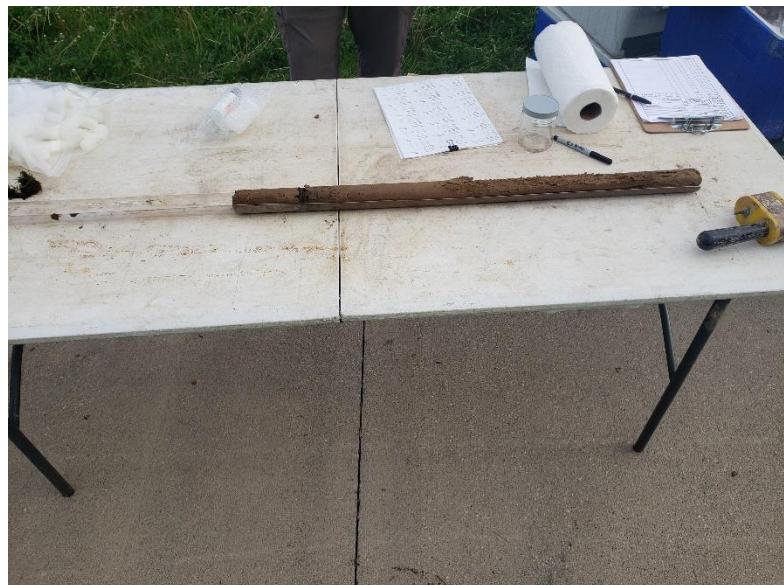
TETRA TECH PROJECT NO. 103X903021F0035  Direction: N/A	DESCRIPTION	This photograph shows DPT-4 soil core from 5-10 feet bgs. Sample collected within 9-10 feet bgs identified as 8811-2.	2
	CLIENT	U.S. Environmental Protection Agency Region 7	Date
	PHOTOGRAPHER	Tim Barbeau	5/4/2021

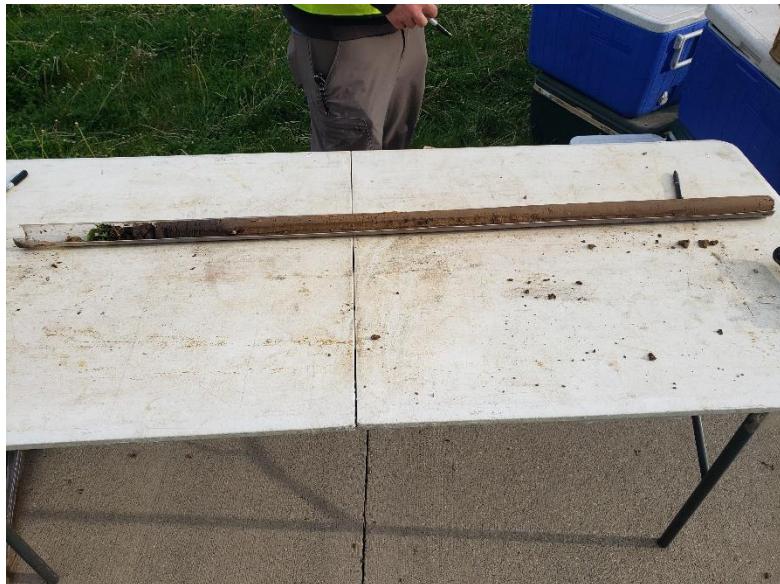
TETRA TECH PROJECT NO. 103X903021F0035	DESCRIPTION	This photograph shows DPT-8 soil core from 0-5 feet bgs. Sample collected within 4-5 feet bgs identified as 8811-3.	3
Direction: N/A	CLIENT	U.S. Environmental Protection Agency Region 7	Date
	PHOTOGRAPHER	Tim Barbeau	5/4/2021

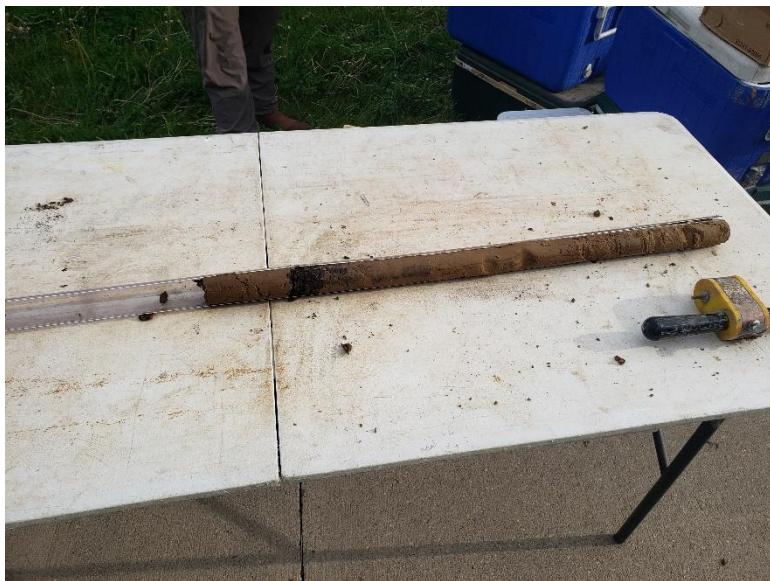
TETRA TECH PROJECT NO. 103X903021F0035	DESCRIPTION	This photograph shows DPT-8 soil core from 5-10 feet bgs. Sample collected within 9-10 feet bgs identified as 8811-4.	4
Direction: N/A	CLIENT	U.S. Environmental Protection Agency Region 7	Date
	PHOTOGRAPHER	Tim Barbeau	5/4/2021

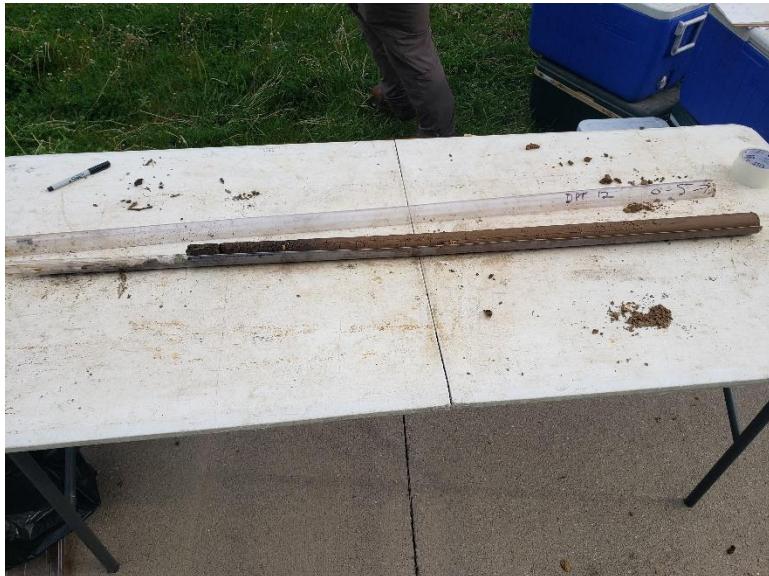
TETRA TECH PROJECT NO. 103X903021F0035	DESCRIPTION	This photograph shows DPT-12 soil core from 0-5 feet bgs. Sample collected within 4-5 feet bgs identified as 8811-5.	5
Direction: N/A	CLIENT	U.S. Environmental Protection Agency Region 7	Date
	PHOTOGRAPHER	Tim Barbeau	5/4/2021

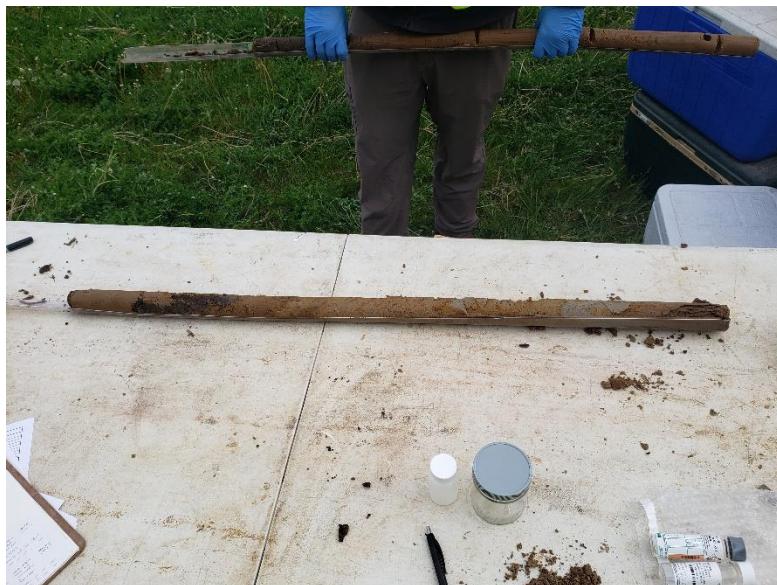
TETRA TECH PROJECT NO. 103X903021F0035	DESCRIPTION	This photograph shows DPT-12 soil core from 5-10 feet bgs. Sample collected within 9-10 feet bgs identified as 8811-6.	6
Direction: N/A	CLIENT	U.S. Environmental Protection Agency Region 7	Date
	PHOTOGRAPHER	Tim Barbeau	5/4/2021

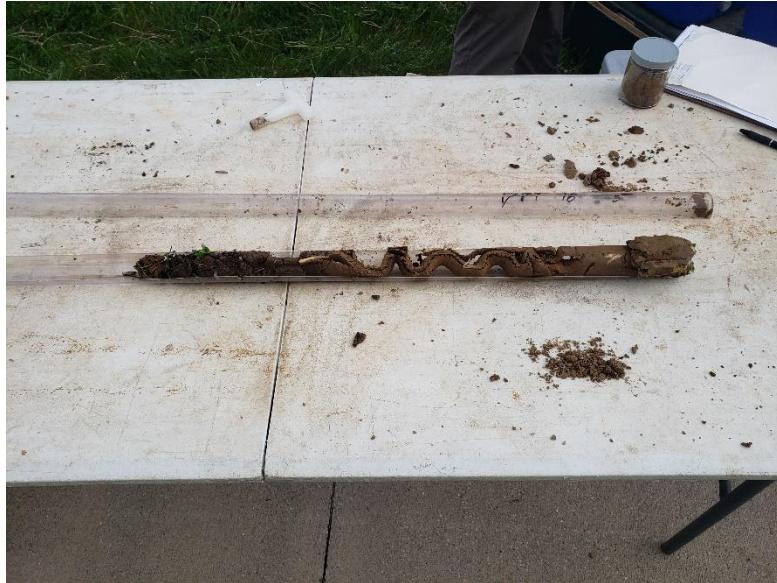
TETRA TECH PROJECT NO. 103X903021F0035	DESCRIPTION	This photograph shows DPT-16 soil core from 0-5 feet bgs. Sample collected within 4-5 feet bgs identified as 8811-7.	7
Direction: N/A	CLIENT	U.S. Environmental Protection Agency Region 7	Date
	PHOTOGRAPHER	Tim Barbeau	5/4/2021

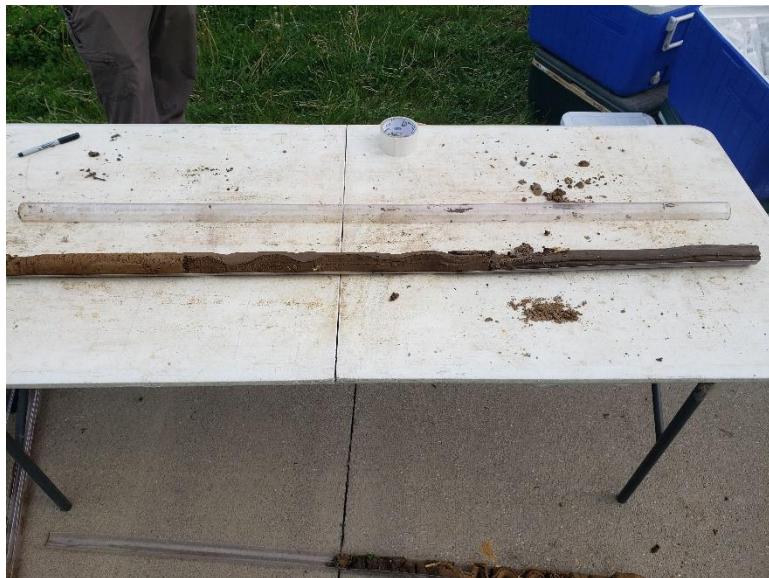
TETRA TECH PROJECT NO. 103X903021F0035	DESCRIPTION	This photograph shows DPT-16 soil core from 5-10 feet bgs. Sample collected within 9-10 feet bgs identified as 8811-8.	8
Direction: N/A	CLIENT	U.S. Environmental Protection Agency Region 7	Date
	PHOTOGRAPHER	Tim Barbeau	5/4/2021

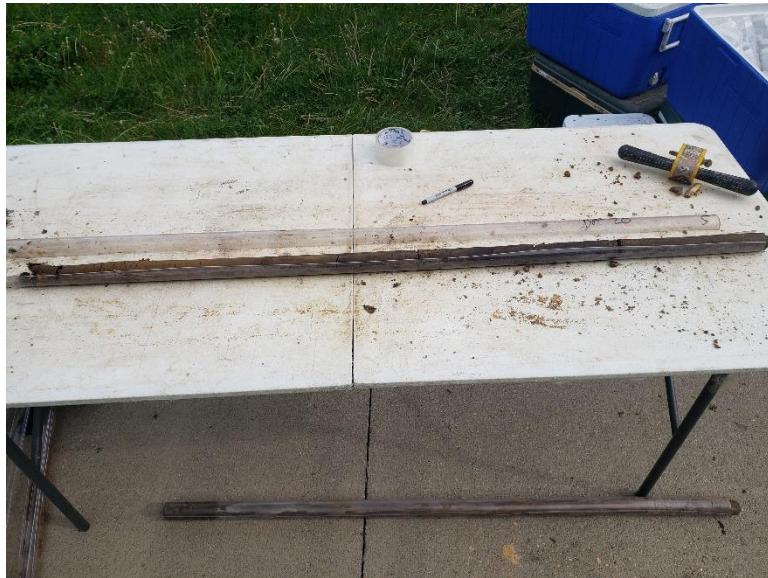
TETRA TECH PROJECT NO. 103X903021F0035	DESCRIPTION	This photograph shows DPT-20 soil core from 0-5 bgs. Sample collected within 4-5 feet bgs identified as 8811-9.	9
Direction: N/A	CLIENT	U.S. Environmental Protection Agency Region 7	Date
	PHOTOGRAPHER	Tim Barbeau	5/4/2021

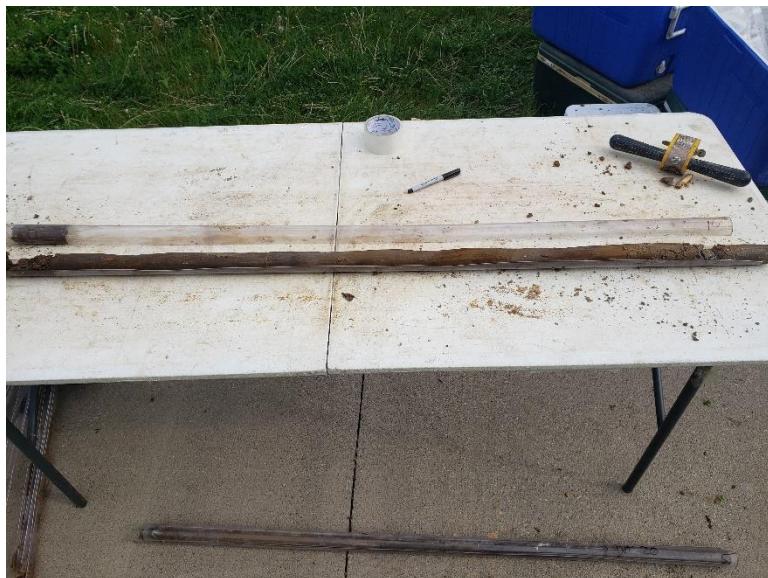
TETRA TECH PROJECT NO. 103X903021F0035	DESCRIPTION	This photograph shows DPT-20 soil core from 5-10 feet bgs. Sample collected within 9-10 feet bgs identified as 8811-10.	10
Direction: N/A	CLIENT	U.S. Environmental Protection Agency Region 7	Date
	PHOTOGRAPHER	Tim Barbeau	5/4/2021

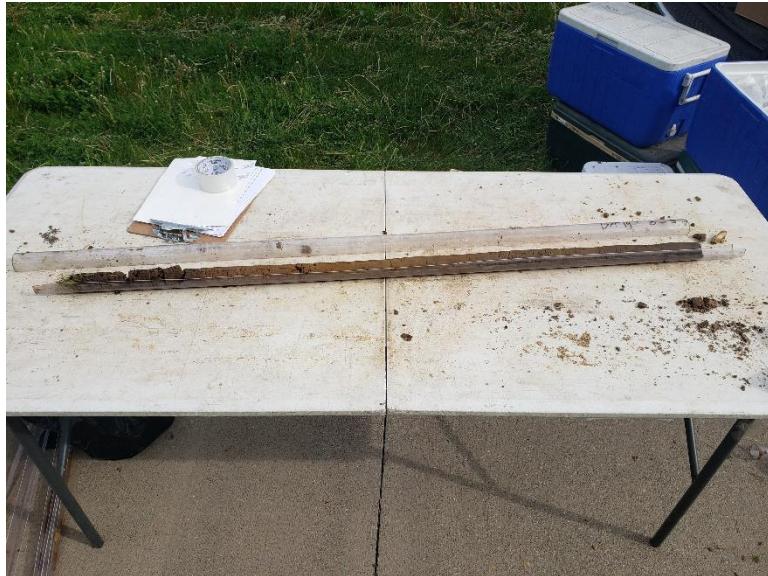
TETRA TECH PROJECT NO. 103X903021F0035	DESCRIPTION	This photograph shows DPT-19 soil core from 0-5 bgs. Sample collected within 4-5 feet bgs identified as 8811-11.	11
Direction: N/A	CLIENT	U.S. Environmental Protection Agency Region 7	Date
	PHOTOGRAPHER	Tim Barbeau	5/4/2021

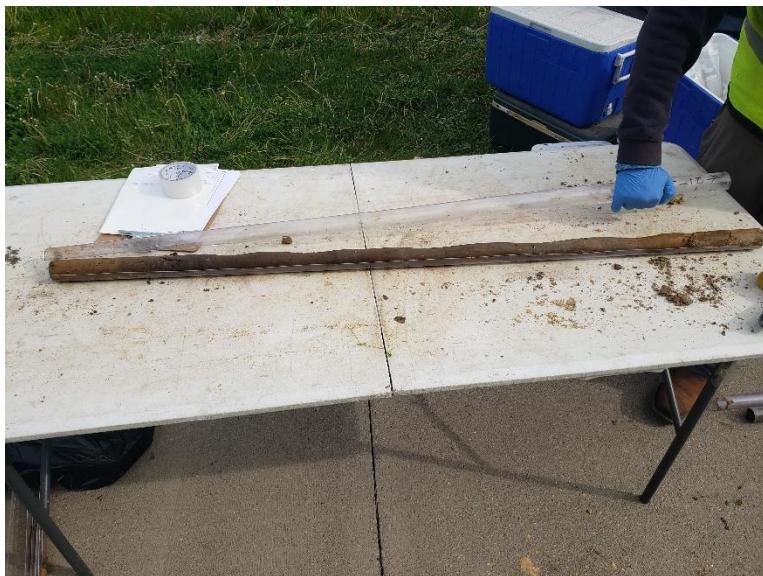
TETRA TECH PROJECT NO. 103X903021F0035	DESCRIPTION	This photograph shows DPT-19 soil core from 5-10 feet bgs. Sample collected within 9-10 feet bgs identified as 8811-12.	12
Direction: N/A	CLIENT	U.S. Environmental Protection Agency Region 7	Date
	PHOTOGRAPHER	Tim Barbeau	5/4/2021

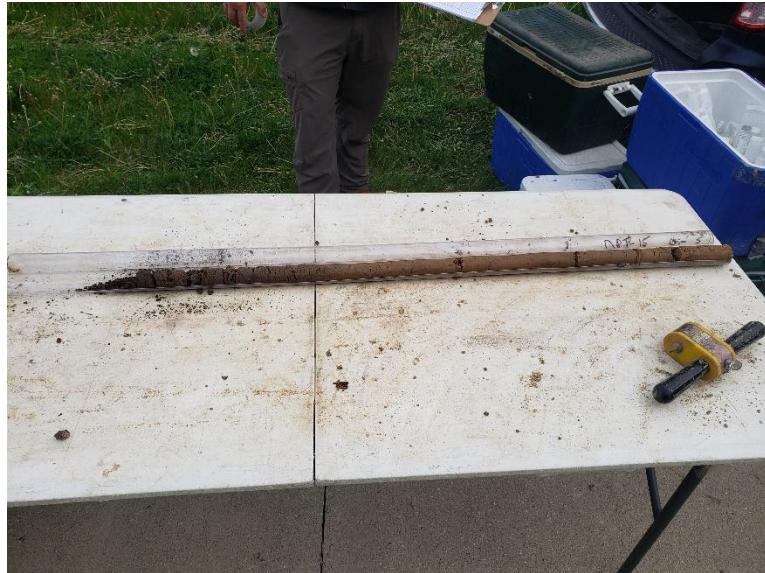
TETRA TECH PROJECT NO. 103X903021F0035  Direction: N/A	DESCRIPTION	This photograph shows DPT-15 soil core from 0-5 bgs. Sample collected within 4-5 feet bgs identified as 8811-13.	13
	CLIENT	U.S. Environmental Protection Agency Region 7	Date 5/4/2021
	PHOTOGRAPHER	Tim Barbeau

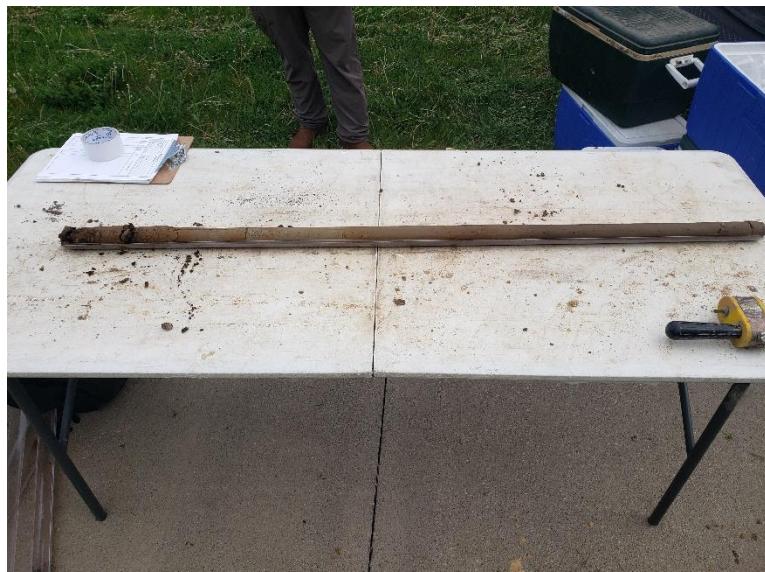
TETRA TECH PROJECT NO. 103X903021F0035  Direction: N/A	DESCRIPTION	This photograph shows DPT-15 soil core from 5-10 feet bgs. Sample collected within 9-10 feet bgs identified as 8811-14.	14
	CLIENT	U.S. Environmental Protection Agency Region 7	Date 5/4/2021
	PHOTOGRAPHER	Tim Barbeau

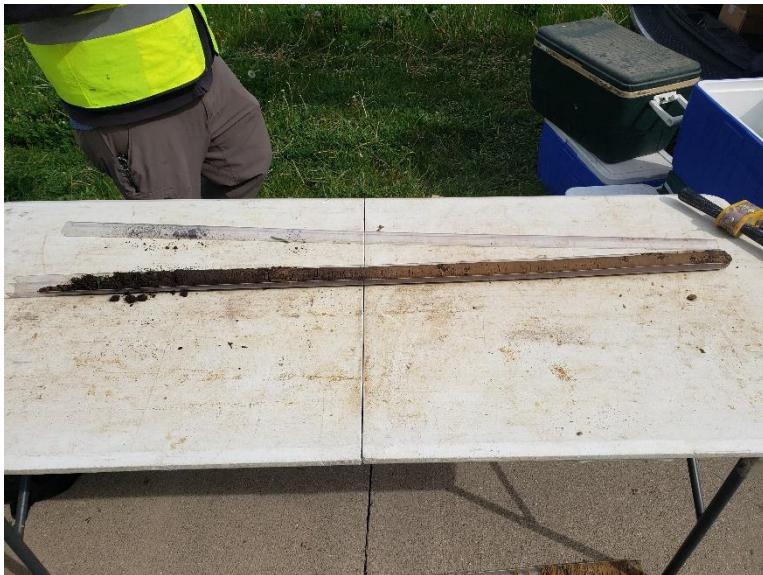
TETRA TECH PROJECT NO. 103X903021F0035 Direction: N/A	DESCRIPTION	This photograph shows DPT-11 soil core from 0-5 bgs. Sample collected within 4-5 feet bgs identified as 8811-15.	15
	CLIENT	U.S. Environmental Protection Agency Region 7	Date
	PHOTOGRAPHER	Tim Barbeau	5/4/2021

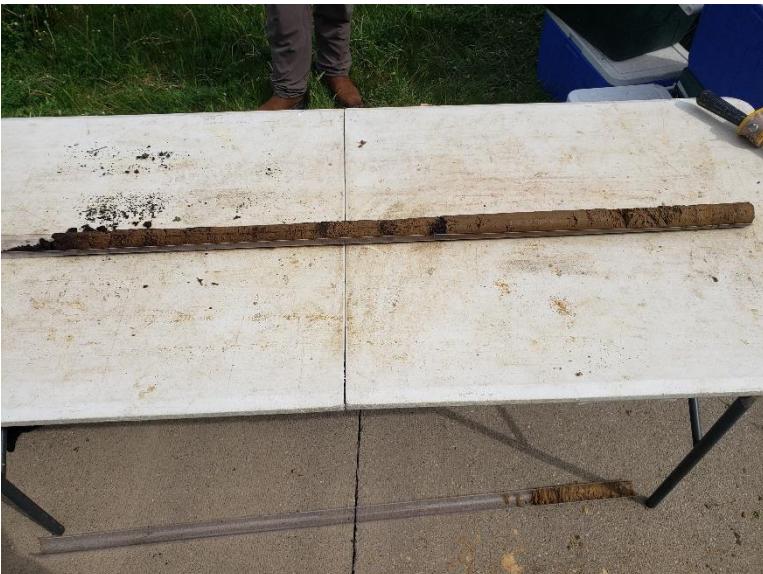
TETRA TECH PROJECT NO. 103X903021F0035 Direction: N/A	DESCRIPTION	This photograph shows DPT-11 soil core from 5-10 feet bgs. Sample collected within 9-10 feet bgs identified as 8811-16.	16
	CLIENT	U.S. Environmental Protection Agency Region 7	Date
	PHOTOGRAPHER	Tim Barbeau	5/4/2021

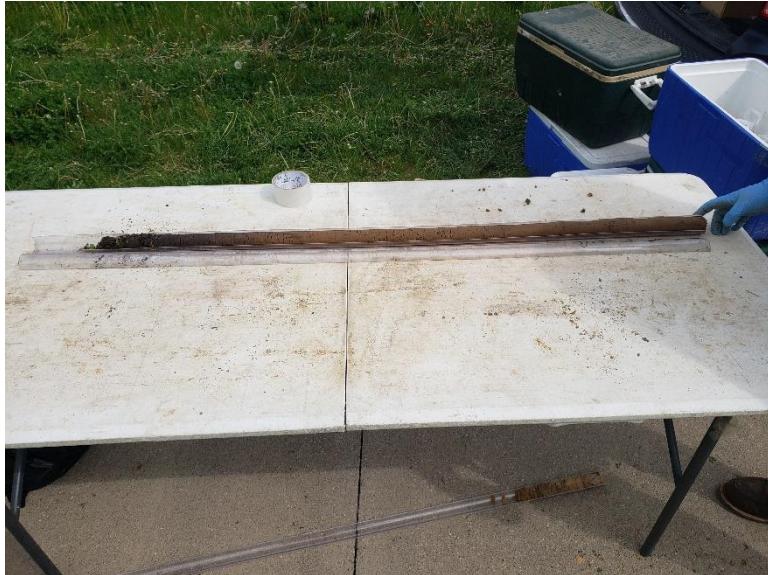
TETRA TECH PROJECT NO. 103X903021F0035	DESCRIPTION	This photograph shows DPT-7 soil core from 0-5 bgs. Sample collected within 4-5 feet bgs identified as 8811-17.	17
Direction: N/A	CLIENT	U.S. Environmental Protection Agency Region 7	Date
	PHOTOGRAPHER	Tim Barbeau	5/4/2021

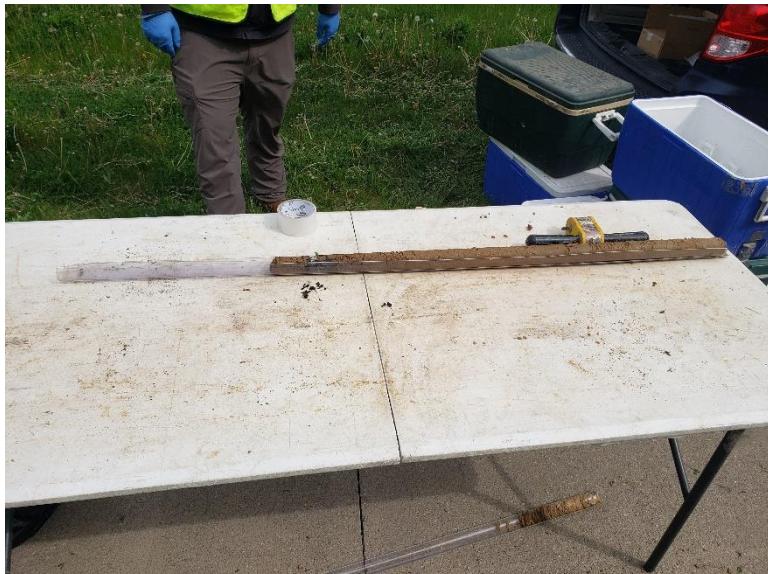
TETRA TECH PROJECT NO. 103X903021F0035	DESCRIPTION	This photograph shows DPT-7 soil core from 5-10 feet bgs. Sample collected within 9-10 feet bgs identified as 8811-18.	18
Direction: N/A	CLIENT	U.S. Environmental Protection Agency Region 7	Date
	PHOTOGRAPHER	Tim Barbeau	5/4/2021

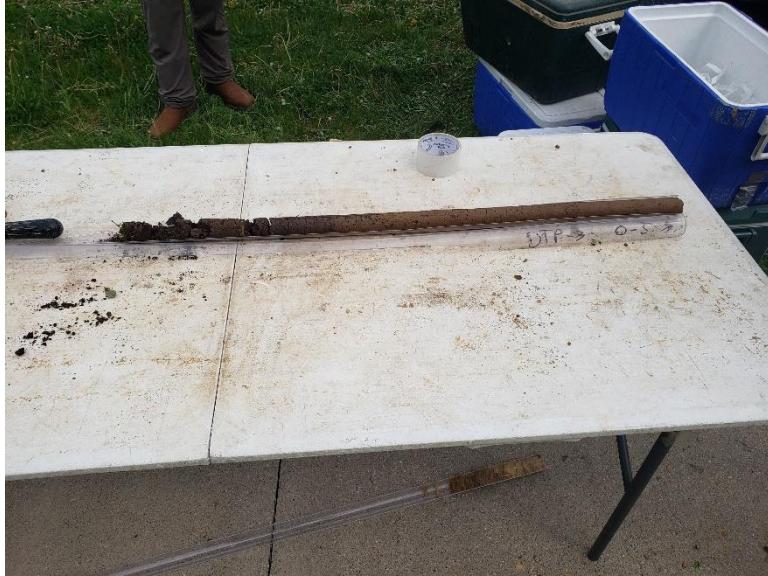
TETRA TECH PROJECT NO. 103X903021F0035	DESCRIPTION	This photograph shows DPT-3 soil core from 0-5 bgs. Sample collected within 4-5 feet bgs identified as 8811-19.	19
Direction: N/A	CLIENT	U.S. Environmental Protection Agency Region 7	Date
	PHOTOGRAPHER	Tim Barbeau	5/4/2021

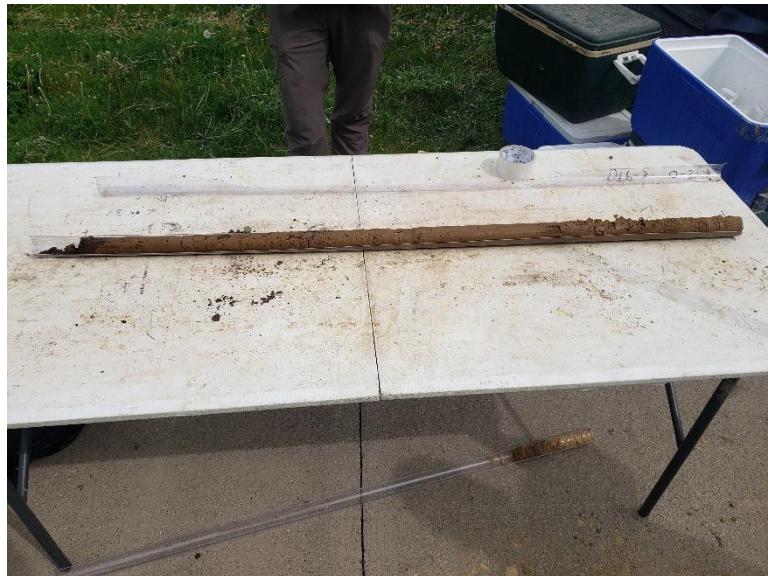
TETRA TECH PROJECT NO. 103X903021F0035	DESCRIPTION	This photograph shows DPT-3 soil core from 5-10 feet bgs. Sample collected within 9-10 feet bgs identified as 8811-20.	20
Direction: N/A	CLIENT	U.S. Environmental Protection Agency Region 7	Date
	PHOTOGRAPHER	Tim Barbeau	5/4/2021

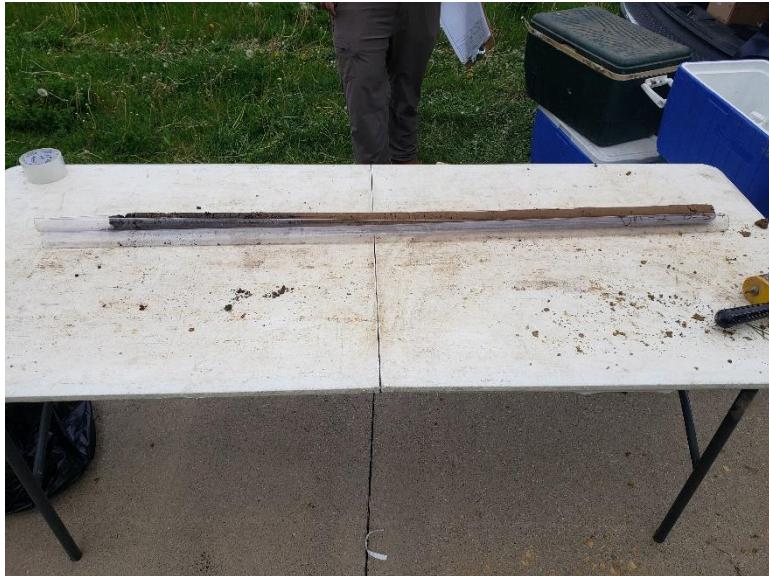
TETRA TECH PROJECT NO. 103X903021F0035	DESCRIPTION	This photograph shows DPT-2 soil core from 0-5 bgs. Sample collected within 4-5 feet bgs identified as 8811-21.	21
Direction: N/A	CLIENT	U.S. Environmental Protection Agency Region 7	Date
	PHOTOGRAPHER	Tim Barbeau	5/4/2021

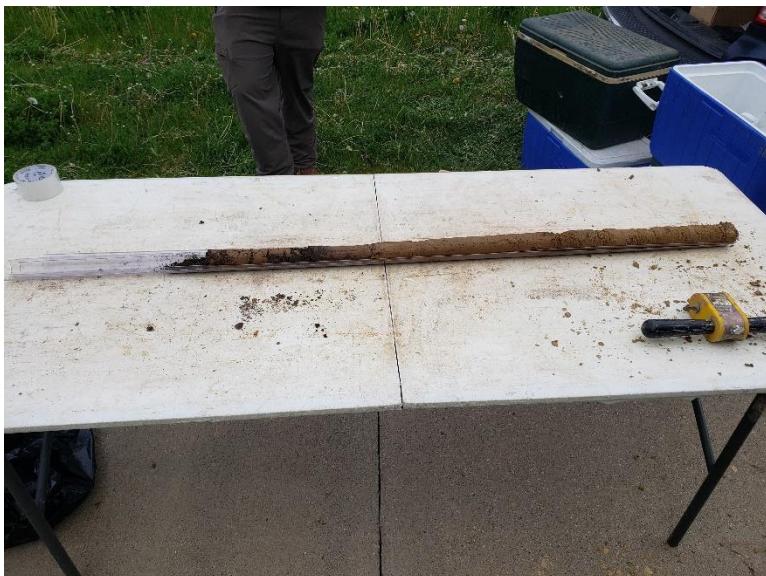
TETRA TECH PROJECT NO. 103X903021F0035	DESCRIPTION	This photograph shows DPT-2 soil core from 5-10 feet bgs. Sample collected within 9-10 feet bgs identified as 8811-22.	22
Direction: N/A	CLIENT	U.S. Environmental Protection Agency Region 7	Date
	PHOTOGRAPHER	Tim Barbeau	5/4/2021

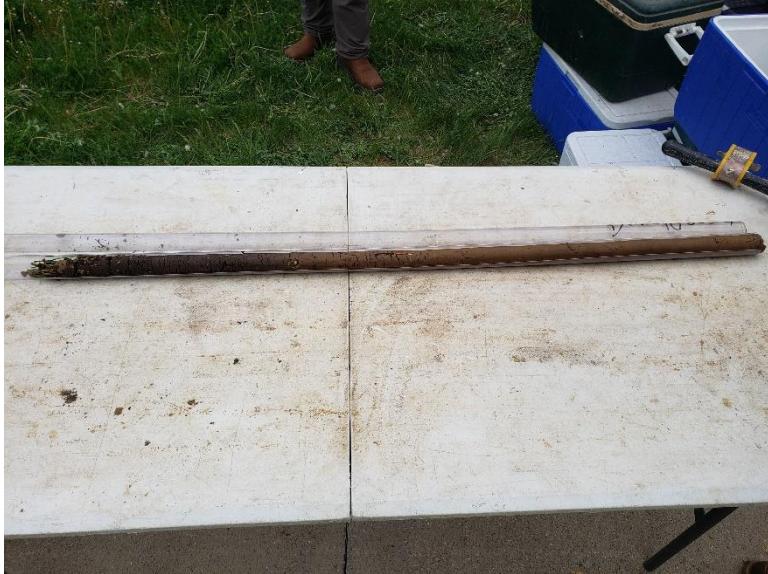
TETRA TECH PROJECT NO. 103X903021F0035  Direction: N/A	DESCRIPTION	This photograph shows DPT-10 soil core from 0-5 bgs. Sample collected within 4-5 feet bgs identified as 8811-23.	23
	CLIENT	U.S. Environmental Protection Agency Region 7	Date
	PHOTOGRAPHER	Tim Barbeau	5/4/2021

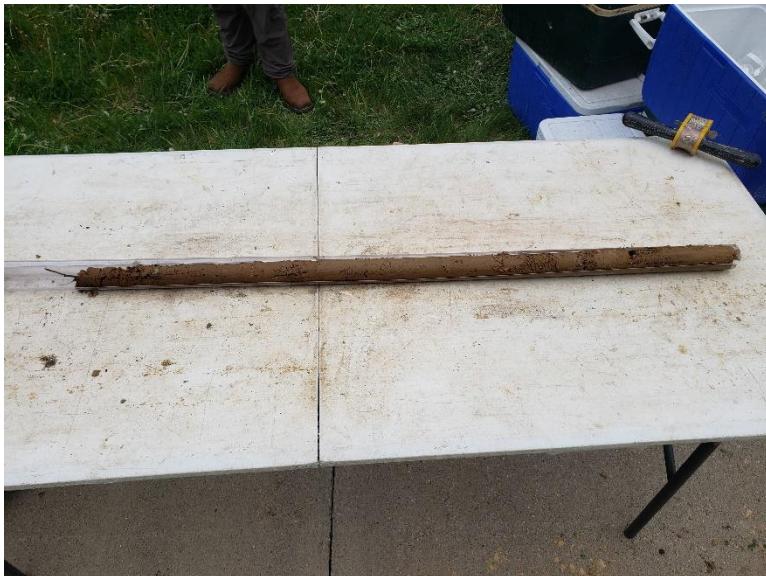
TETRA TECH PROJECT NO. 103X903021F0035  Direction: N/A	DESCRIPTION	This photograph shows DPT-10 soil core from 5-10 feet bgs. Sample collected within 9-10 feet bgs identified as 8811-24.	24
	CLIENT	U.S. Environmental Protection Agency Region 7	Date
	PHOTOGRAPHER	Tim Barbeau	5/4/2021

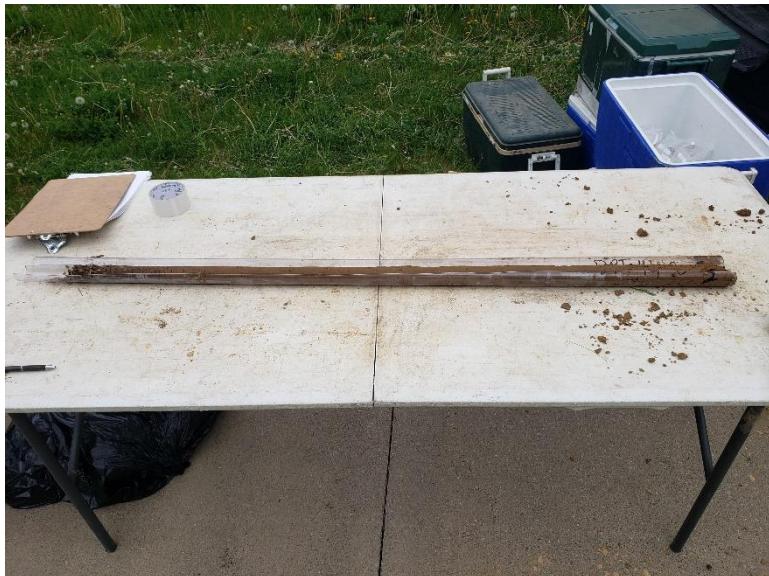
TETRA TECH PROJECT NO. 103X903021F0035	DESCRIPTION	This photograph shows DPT-14 soil core from 0-5 bgs. Sample collected within 4-5 feet bgs identified as 8811-25.	25
Direction: N/A	CLIENT	U.S. Environmental Protection Agency Region 7	Date
	PHOTOGRAPHER	Tim Barbeau	5/4/2021

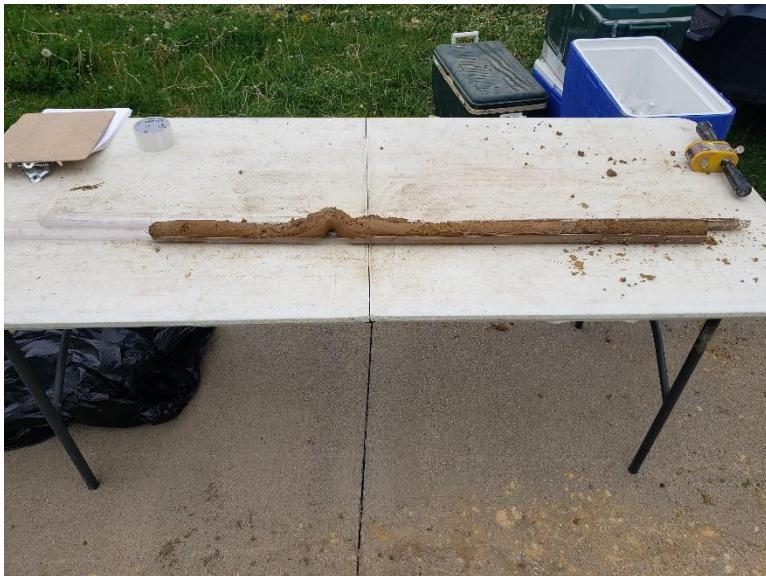
TETRA TECH PROJECT NO. 103X903021F0035	DESCRIPTION	This photograph shows DPT-14 soil core from 5-10 feet bgs. Sample collected within 9-10 feet bgs identified as 8811-26.	26
Direction: N/A	CLIENT	U.S. Environmental Protection Agency Region 7	Date
	PHOTOGRAPHER	Tim Barbeau	5/4/2021

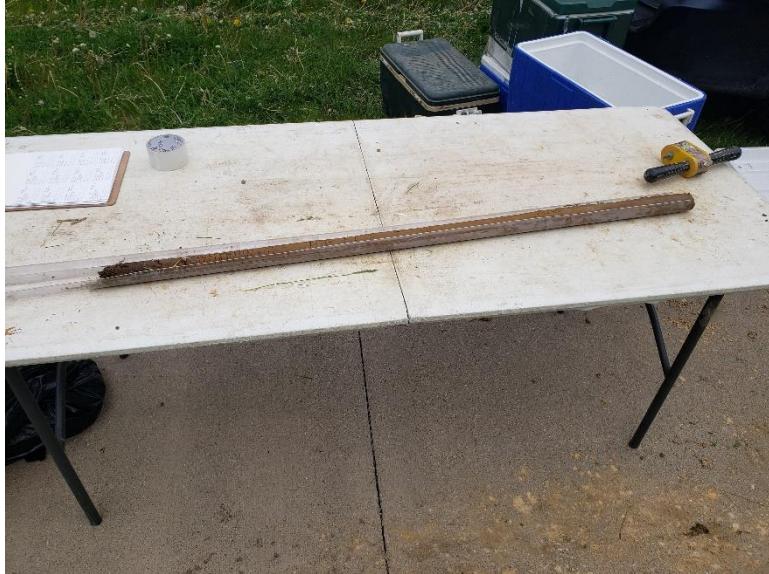
TETRA TECH PROJECT NO. 103X903021F0035	DESCRIPTION	This photograph shows DPT-18 soil core from 0-5 bgs. Sample collected within 4-5 feet bgs identified as 8811-27.	27
	CLIENT	U.S. Environmental Protection Agency Region 7	Date
	Direction: N/A	PHOTOGRAPHER	5/4/2021

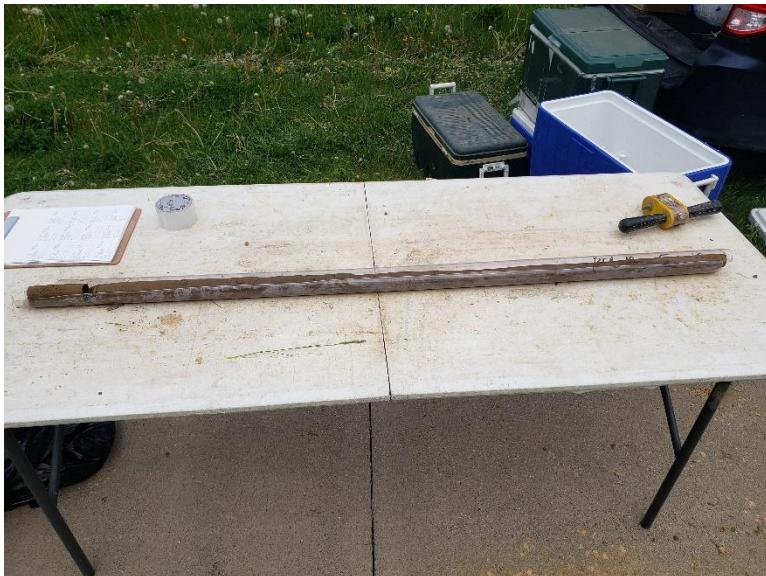
TETRA TECH PROJECT NO. 103X903021F0035	DESCRIPTION	This photograph shows DPT-18 soil core from 5-10 feet bgs. Sample collected within 9-10 feet bgs identified as 8811-28.	28
	CLIENT	U.S. Environmental Protection Agency Region 7	Date
	Direction: N/A	PHOTOGRAPHER	5/4/2021

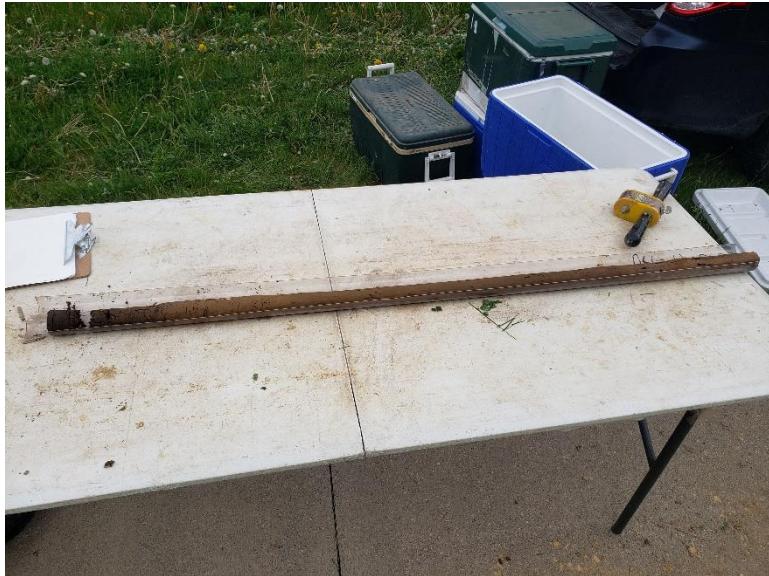
TETRA TECH PROJECT NO. 103X903021F0035 Direction: N/A	DESCRIPTION	This photograph shows DPT-17 soil core from 0-5 bgs. Sample collected within 4-5 feet bgs identified as 8811-29.	29
	CLIENT	U.S. Environmental Protection Agency Region 7	Date
	PHOTOGRAPHER	Tim Barbeau	5/4/2021

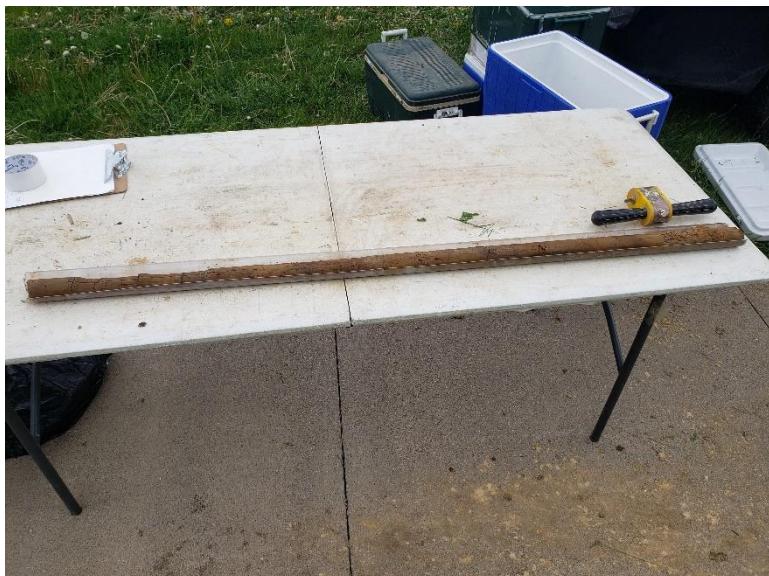
TETRA TECH PROJECT NO. 103X903021F0035 Direction: N/A	DESCRIPTION	This photograph shows DPT-17 soil core from 5-10 feet bgs. Sample collected within 9-10 feet bgs identified as 8811-30.	30
	CLIENT	U.S. Environmental Protection Agency Region 7	Date
	PHOTOGRAPHER	Tim Barbeau	5/4/2021

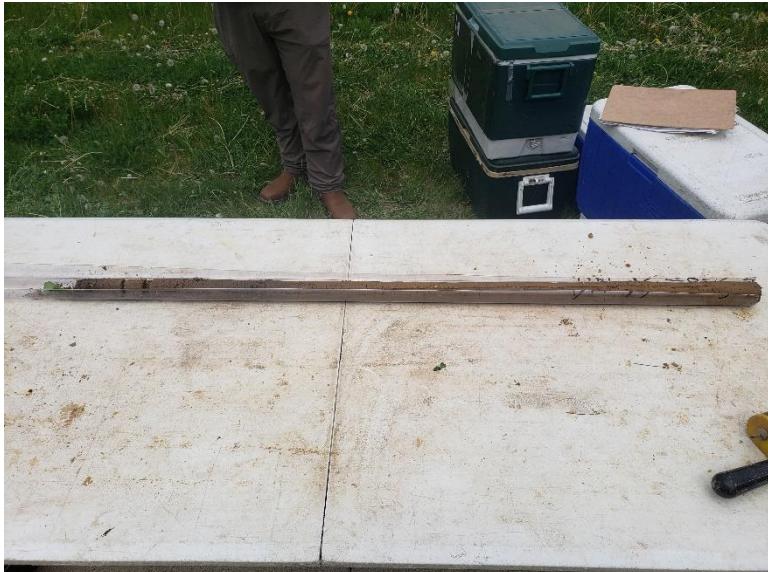
TETRA TECH PROJECT NO. 103X903021F0035	DESCRIPTION	This photograph shows DPT-13 soil core from 0-5 bgs. Sample collected within 3-5 feet bgs identified as 8811-31.	31
	CLIENT	U.S. Environmental Protection Agency Region 7	Date
	PHOTOGRAPHER	Tim Barbeau	5/4/2021

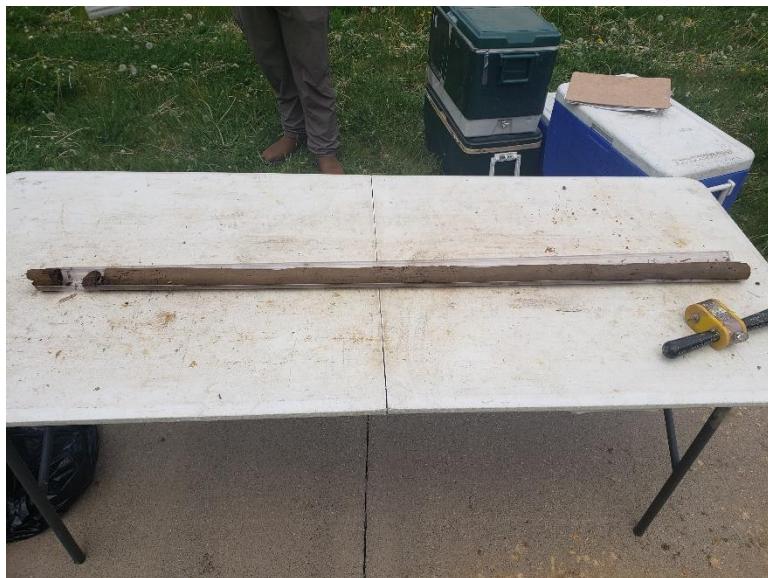
TETRA TECH PROJECT NO. 103X903021F0035	DESCRIPTION	This photograph shows DPT-13 soil core from 5-10 feet bgs. Sample collected within 9-10 feet bgs identified as 8811-32.	32
	CLIENT	U.S. Environmental Protection Agency Region 7	Date
	PHOTOGRAPHER	Tim Barbeau	5/4/2021

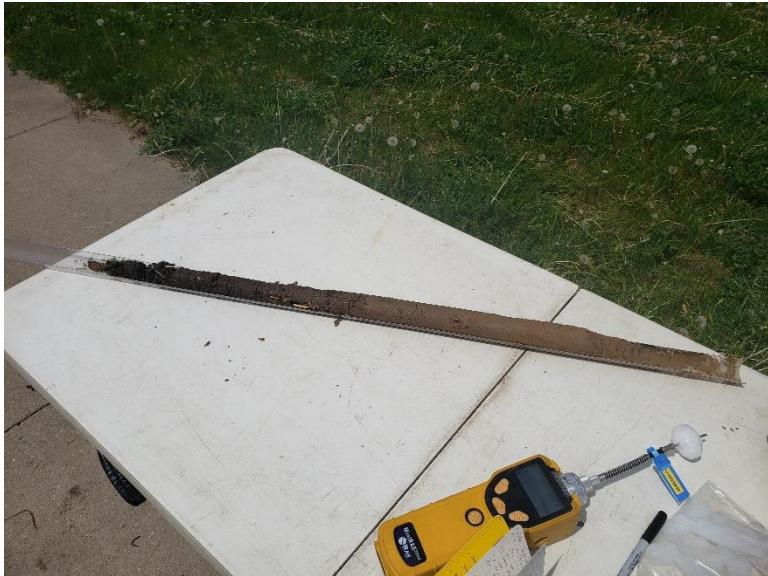
TETRA TECH PROJECT NO. 103X903021F0035	DESCRIPTION	This photograph shows DPT-6 soil core from 0-5 bgs. Sample collected within 4-5 feet bgs identified as 8811-33.	33
Direction: N/A	CLIENT	U.S. Environmental Protection Agency Region 7	Date
	PHOTOGRAPHER	Tim Barbeau	5/4/2021

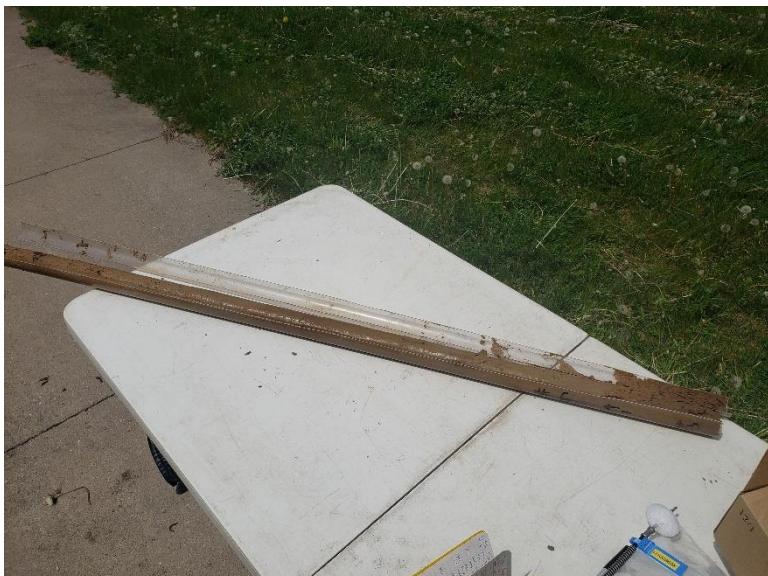
TETRA TECH PROJECT NO. 103X903021F0035	DESCRIPTION	This photograph shows DPT-6 soil core from 5-10 feet bgs. Sample collected within 9-10 feet bgs identified as 8811-34.	34
Direction: N/A	CLIENT	U.S. Environmental Protection Agency Region 7	Date
	PHOTOGRAPHER	Tim Barbeau	5/4/2021

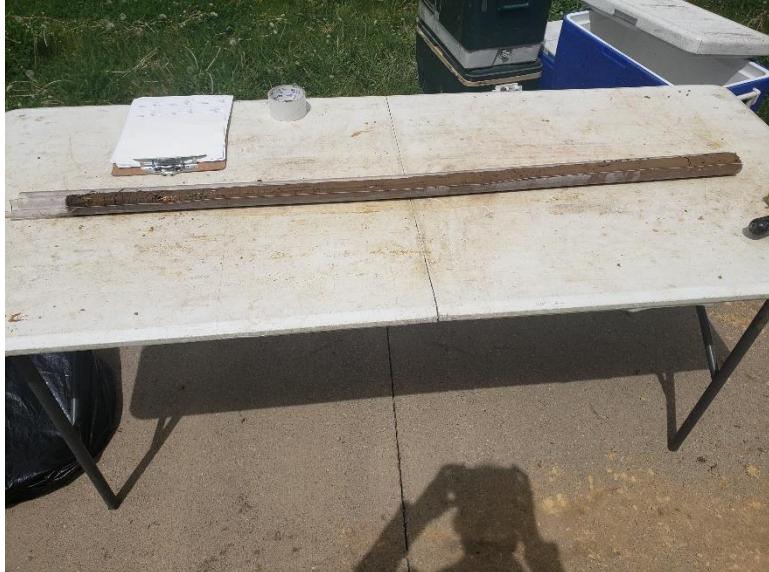
TETRA TECH PROJECT NO. 103X903021F0035	DESCRIPTION	This photograph shows DPT-9 soil core from 0-5 bgs. Sample collected within 4-5 feet bgs identified as 8811-35.	35
Direction: N/A	CLIENT	U.S. Environmental Protection Agency Region 7	Date
	PHOTOGRAPHER	Tim Barbeau	5/4/2021
